Monitoring Cruise at the
Central Long Island Sound
Disposal Site
September 1995

Disposal Area Monitoring System DAMOS

Contribution 118
November 1997

Report No.
SAIC 373

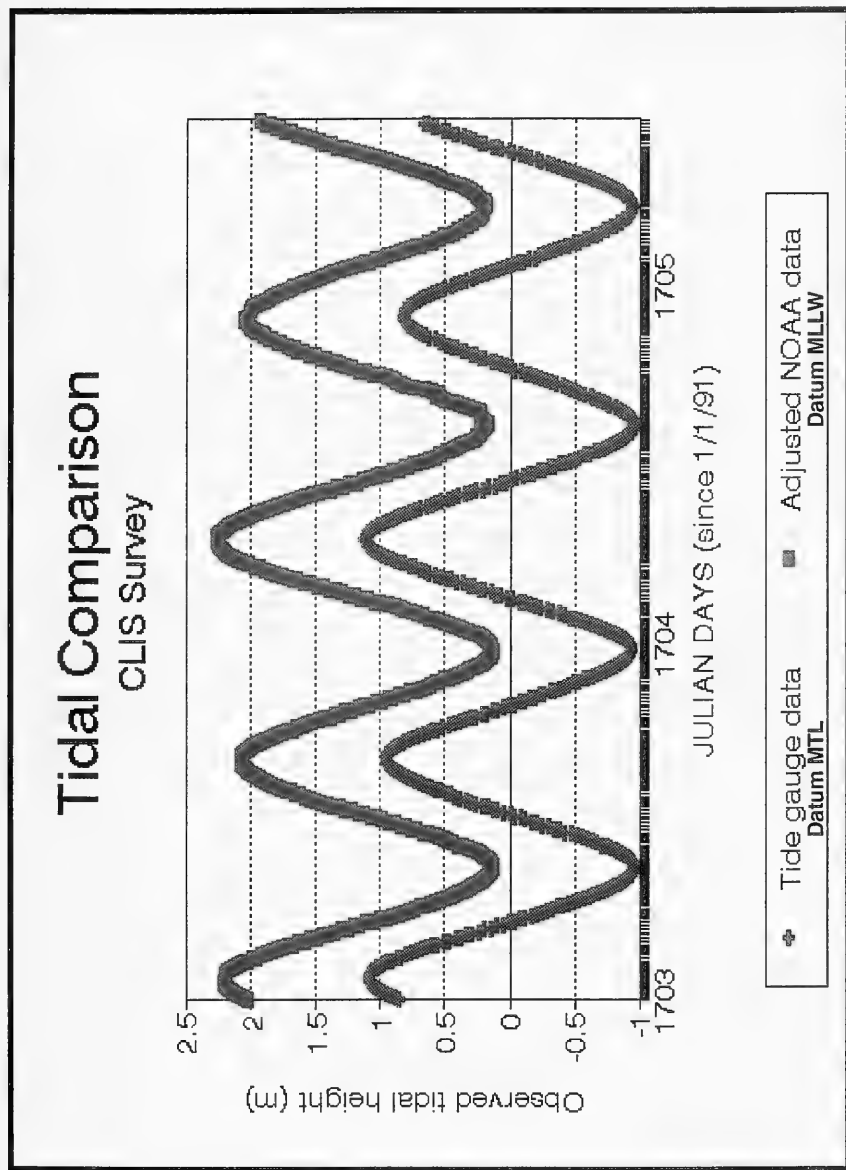
Figure 2-2. Comparisons of the two types of tidal data collected for the September 1995 bathymetric surveys. Differences in tidal height are due to datums.

During the bathymetric survey, a Seabird Instruments, Inc. SBE 26-03 Sea Gauge wave and tide recorder was used to collect tidal data on-site. The tide gauge, deployed in the survey area, recorded pressure values every six minutes. After conversion, the pressure readings provided a constant record of tidal variations in the survey area based on a mean tidal level (MTL) datum. These observed tidal data were later used to compare and verify the corrected NOAA data generated from the Bridgeport Harbor station (Figure 2-2).

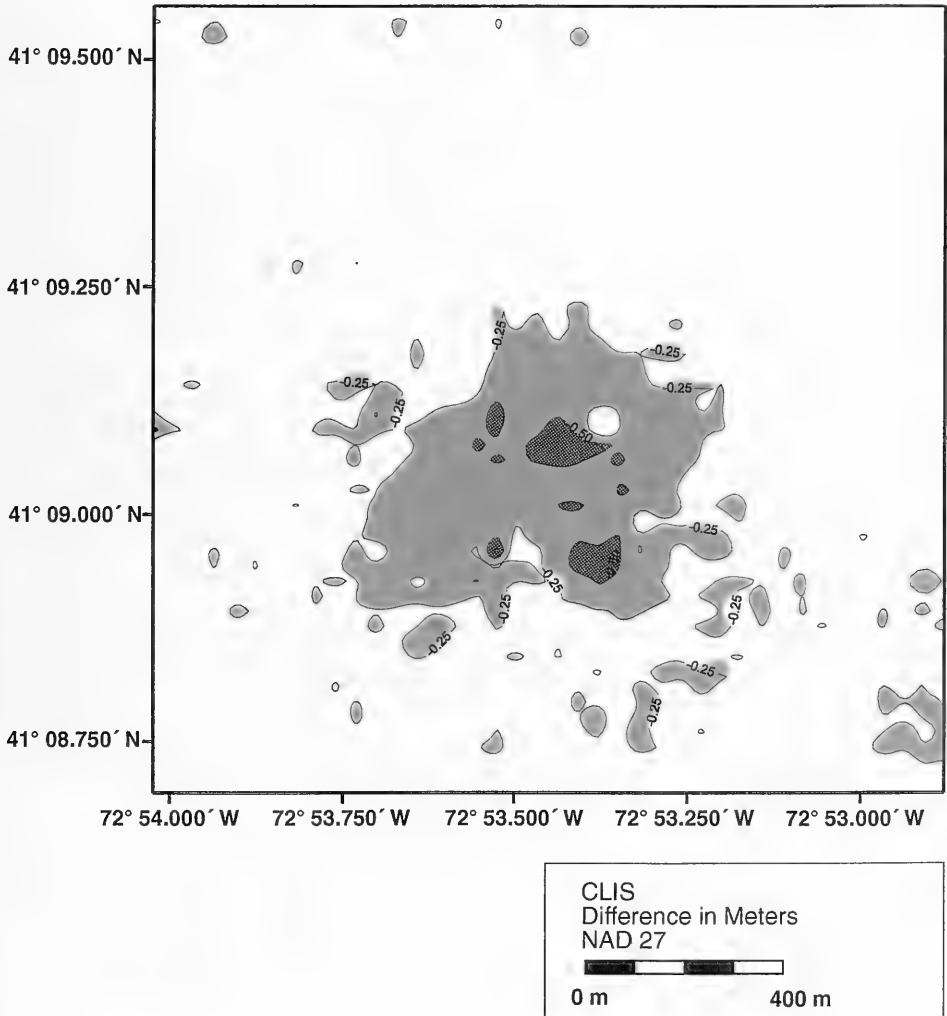
Figure 3-3. Depth difference plot of the postcap survey of March 1994 versus the September 1995 survey over the NHAV 93 mound, 0.25 m contour interval

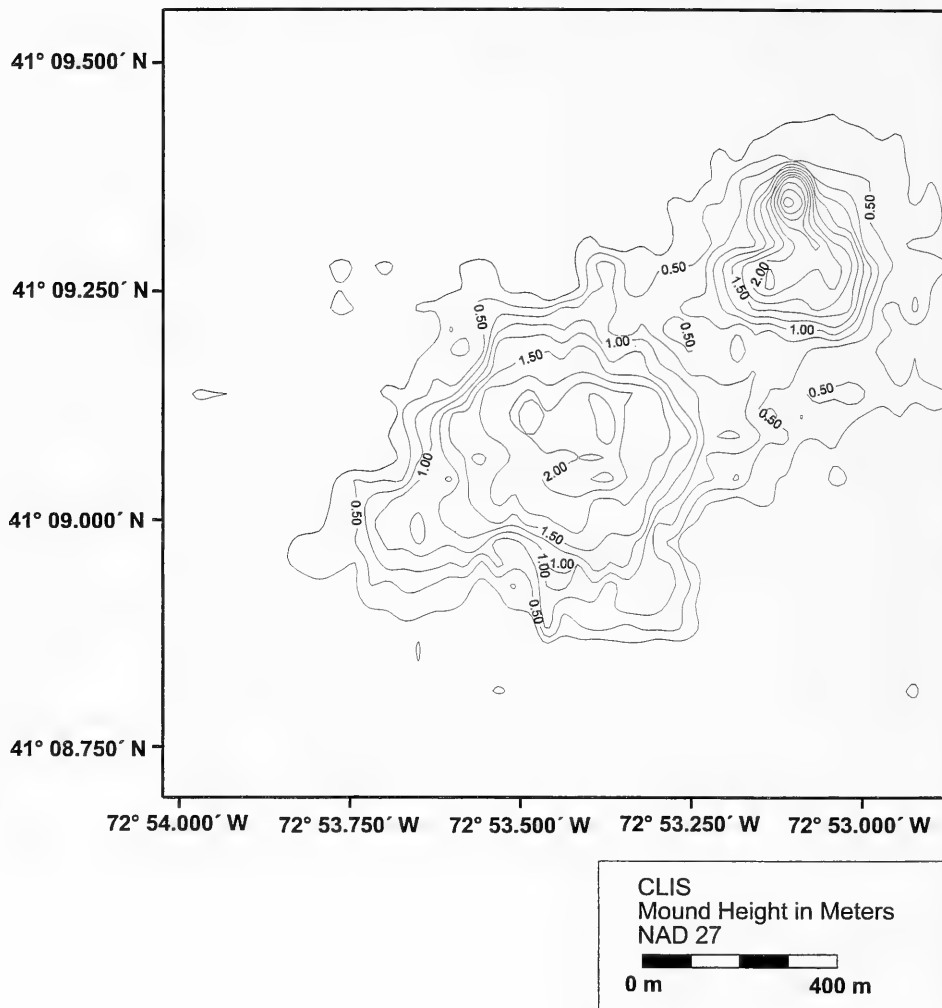
Figure 3-4. Depth difference plot of the baseline survey of September 1993 versus the September 1995 survey, 0.25 m contour interval. Chart represents the total apparent accumulation of dredged material since September 1993.

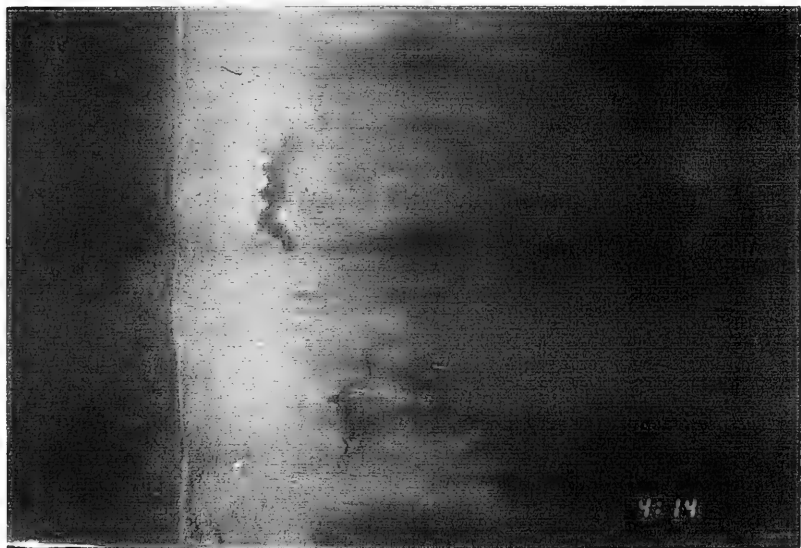
Figure 3-8. REMOTS® photographs showing the improving conditions at Station CTR over the NHA V 93 mound during the September 1995 (A) survey relative to the July 1994 (B) survey

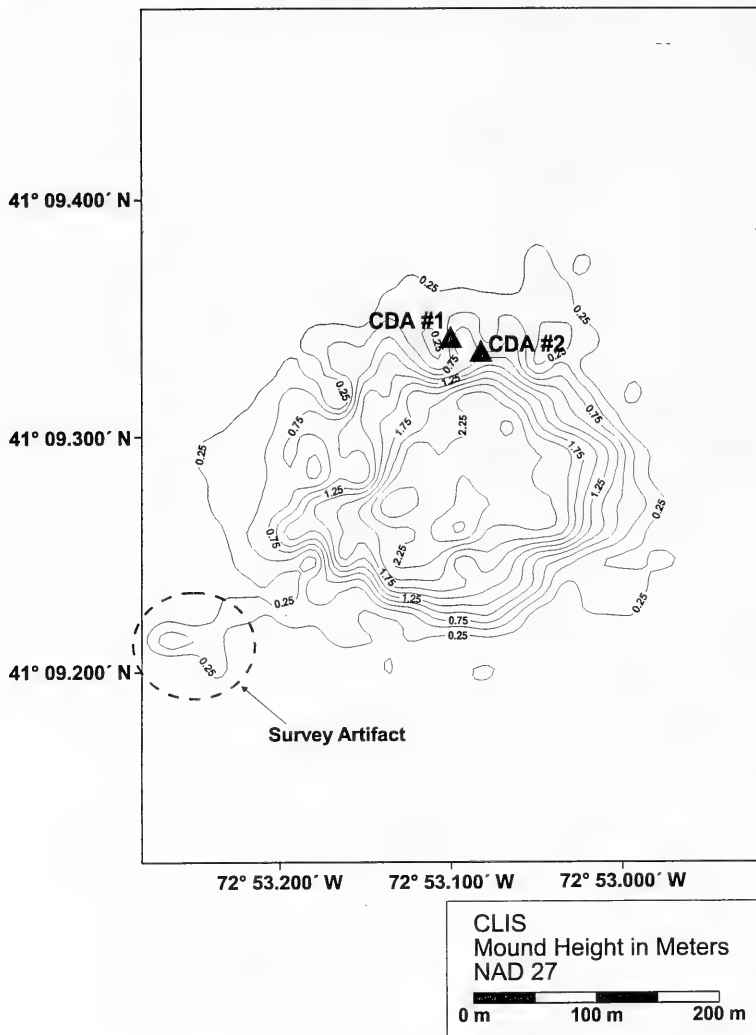
Figure 3-16. Depth difference plot of SAIC's July 1994 baseline survey versus OSI's December 1994 precap survey with plotted CDA 94 buoy positions, 0.25 m contour interval

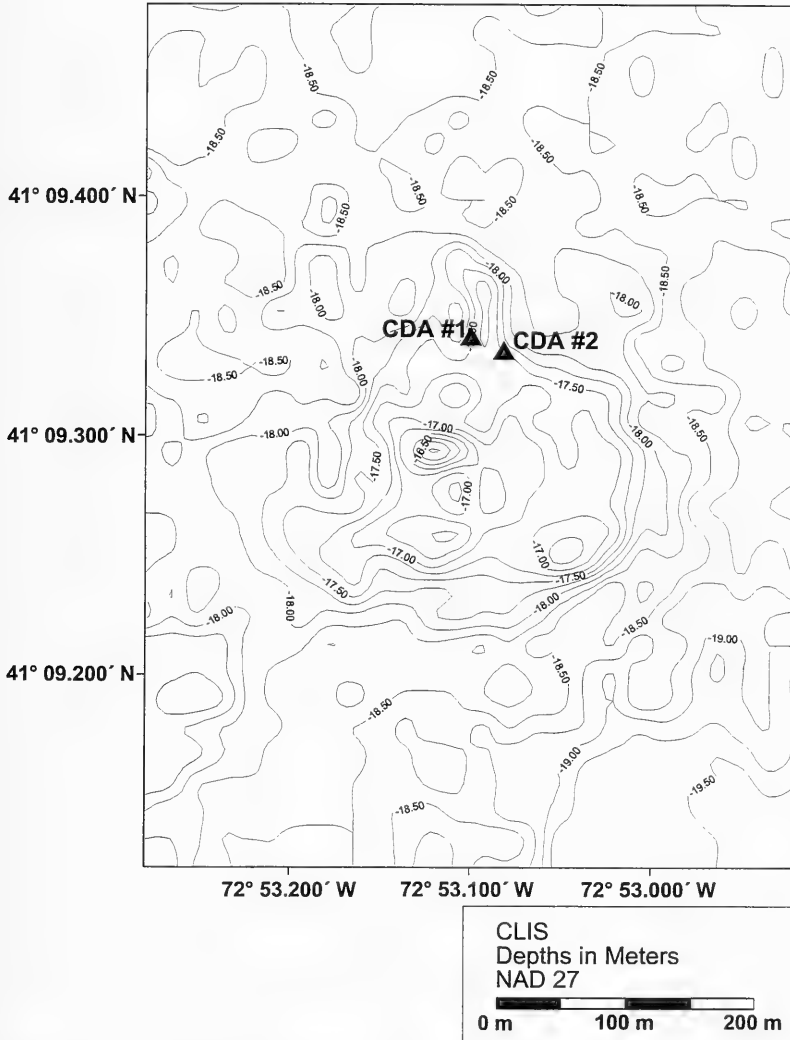
Figure 3-17. Bathymetric chart of the 675 m × 500 m area of concentrated analysis over the CLIS 94 mound at interim cap status, OSI's April 1995 interim cap survey, 0.25 m contour interval

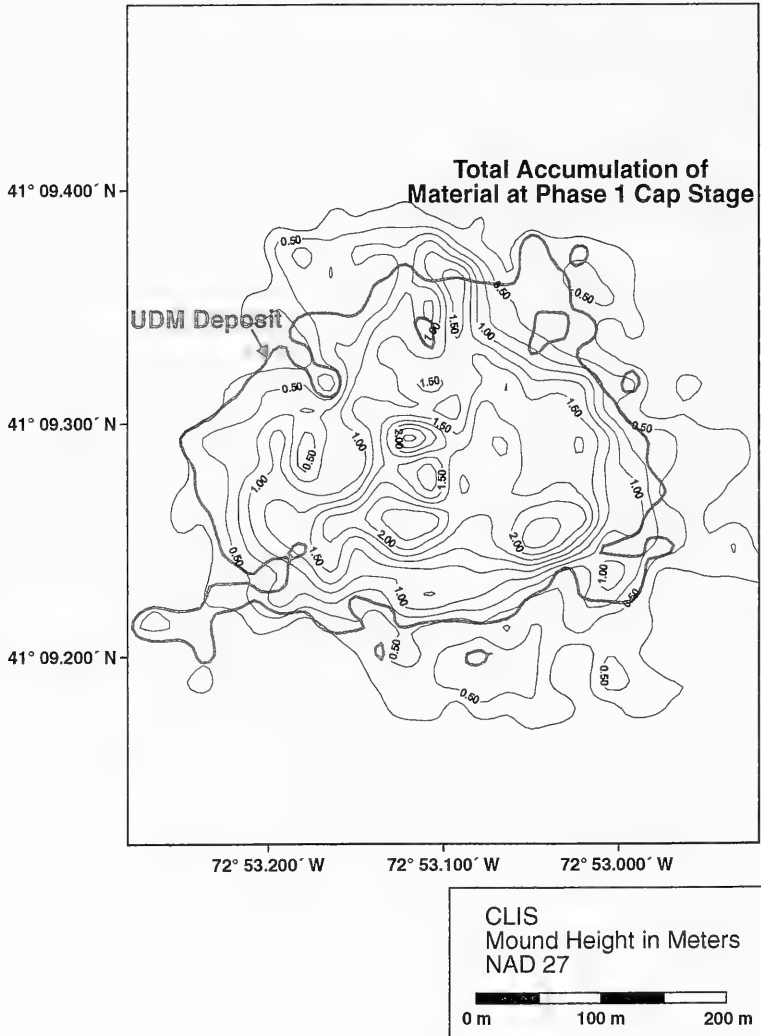
Figure 3-18. Depth difference plot of SAIC's July 1994 baseline survey versus OSI's April 1995 interim cap survey, overlaid with the detectable margin of the UDM deposit, 0.25 m contour interval

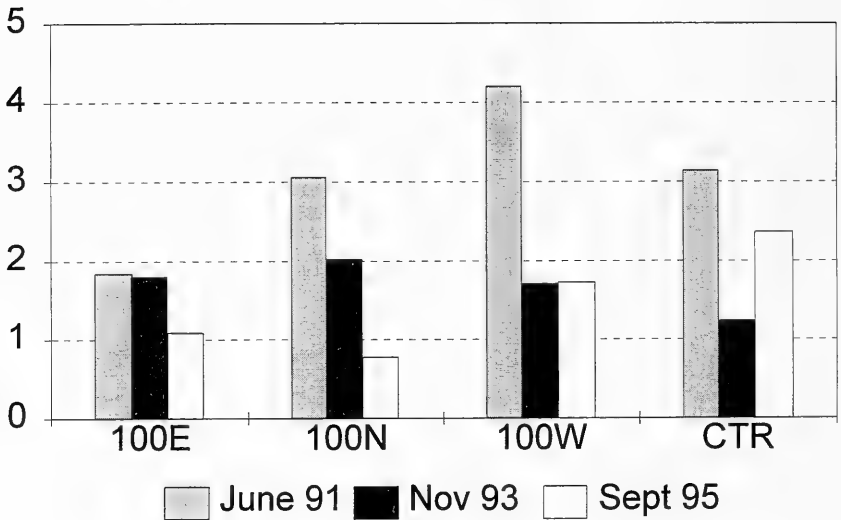
Figure 4-3. Histogram displaying recorded RPD calculations from June 1991, November 1993, and September 1995 at Stations 100E, 100N, 100W, and CTR over the FVP mound

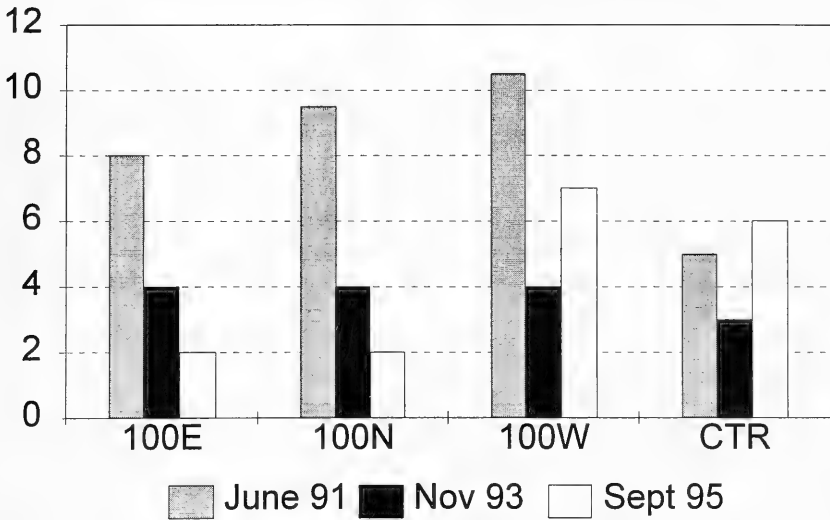
Figure 4-4. Histogram displaying recorded OSI values from June 1991, November 1993, and September 1995 at Stations 100E, 100N, 100W, and CTR over the FVP mound
